SERVICE BULLETIN

No. 355

Piper Aircraft Corporation

Subject: Fuel Selector Valve Lubrication

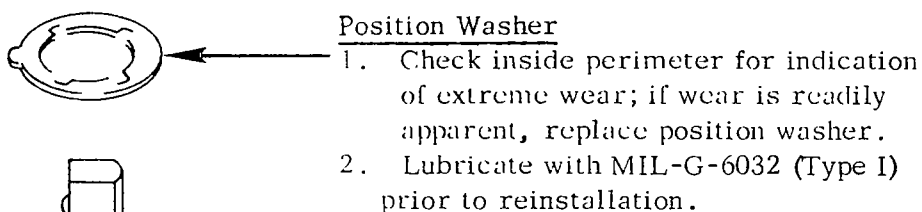
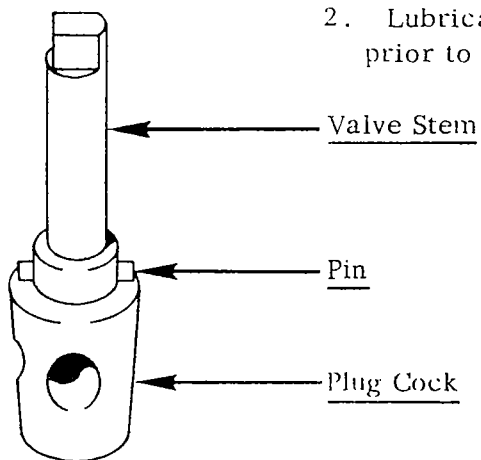
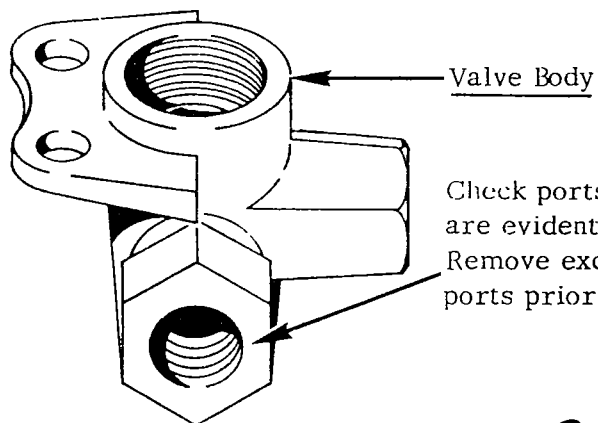
The tapered plug cock unless properly lubricated, is subject to binding or "freezing", caused by (1) fuel coming in contact with the plug cock and gradually dissolving the film of lubricant, (2) presence of foreign material, and (3) hardened or congealed lubricants (usually, wrong type).

Check ports for cracks; if cracks are evident, replace valve. Remove excess grease from ports prior to reinstallation.

1. With the valve removed from the aircraft, remove the valve cap and interior parts (see attached sketch for an exploded view of valve components).
2. Inspect position washer to ascertain that it will not allow the valve to rotate beyond its stop positions. Also, inspect position washer inner perimeter surface for indications of extreme wear; should this be evident, replace position washer (see Material Required, below).

3. Check condition of plug cock and valve body for scored surfaces. The surfaces, if not badly scored, may be conditioned by lapping with a fine grinding compound. Clean away all compound after lapping. If plug cock will not seat properly or if scoring remains evident, replace valve.

4. Check condition of valve stem in the area where the "O" ring seats. Should the stem be worn or damaged so that the "O" ring will not seal, replace valve.

5. With a 10X magnifying glass, inspect valve ports for cracks; if cracks are visible, replace valve.
6. Clean valve of all foreign matter, lubricate plug cock with a light film of MIL-G-6032 (Type I) grease, turn the plug several times in its seat and wipe off any excess, especially in the valve ports. Also, lubricate position washer with a light film of MIL-G-6032 (Type I) grease. Reassemble valve with a new "O" ring, Piper part number 752 822.
