SERVICE No. 582 BULLETIN

Piper Aircraft Corporation

December 6, 1977 S

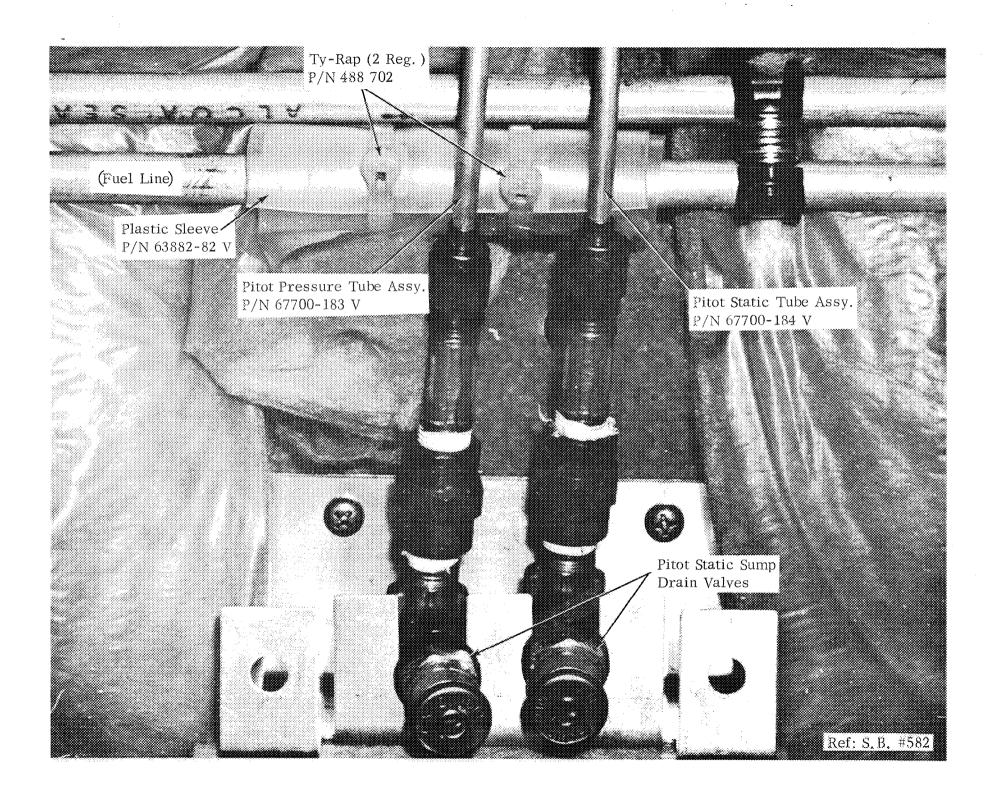
<u>Purpose:</u> The pitot and static sump drain was relocated on the seventy-eight year model aircraft. The possibility now exists that the lines going to these sump drains could possibly chafe on the nuts of a fuel line union running behing the sump drains.

- 1. Remove the upholstered side panel from the left hand side of the fuselage.
- 2. Inspect the two (2) lines connected to the pitot and static sump drain valves for any sign of chafing on the nuts of the fuel line union.
- 3. If any chafing is found then the line(s) must be replaced. Refer to <u>Material</u> <u>Required</u> for tubing part numbers.
- 4. If no chafing is found then install the plastic sleeve over the fuel line union as shown in the attached sketch.
- 5. Replace the side panel.
- 6. Make the appropriate log book entry that this Service Bulletin has been complied with.

Material Required: One (1) plastic sleeve Piper Part No. 63882-82V, two (2) ty-raps Piper part number 488 702V (MS3367-1-9). If required by instruction number three (3), one (1) 67700-183V and one (1) 67700-184V, Tubes.
