# SERVICE BULLETIN

No. 638

Piper Aircraft Corporation

Inspection of Fuel Line Union Fittings

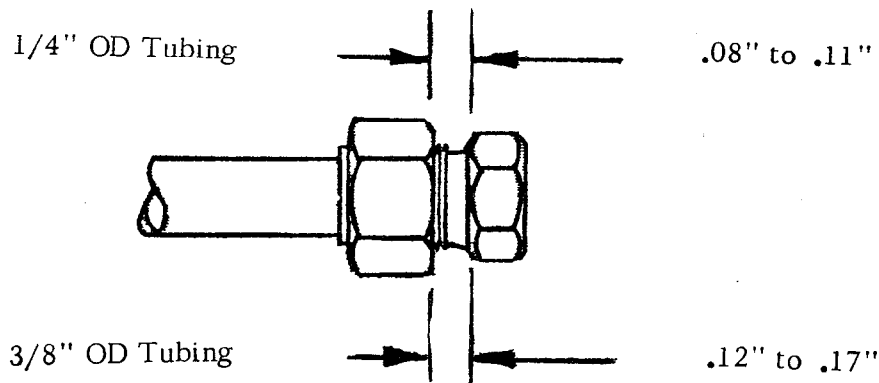
Instructions: (continued)FIGURE I

Reports have been received from the field of fuel leaks at the interconnecting unions (Parker - Hannifin) that are used in several places in the fuel system. This has resulted in fuel leakage and fumes within the cabin. This leakage is due to insufficient tightening of the fitting during installation.

5. After the torquing of each fitting, measure the distance between the face of union nut and face of the tubing nut. See Figure I for tolerance.

6. If any fittings are found to be out of tolerance, refer to Part B, below.
7. After all of the unions have been checked for proper tightness and all repairs (if required) have been made, insure that the airplane is full of fuel and run engine for three (3) to five (5) minutes on each tank.
8. After engine shut down, wiggle all unions. If any fittings are found to be leaking, repairs must be accomplished as outlined in Part B, below.
9. When the system is found to be leak free, replace the side panel, carpet, access plates and seat.
10. Make appropriate logbook entry of compliance with this Service Release.

1. If the fitting shows evidence of galling, or does not meet the dimensional requirements of Figure I above, or continues to leak after being tightened, as outlined in Part A, item 5, above, it shall be repaired using items 2, 3, or 4, below.
2. The recommended repair is to remove the leaking union and replace it using a standard AN fitting as outlined in AC43.13-1. (1972 issue) Paragraph 392. This will require cutting off the swaged ferrule and adding a short length of tubing.
