SERVICE BULLETIN

No. 717

Piper Aircraft Corporation

Fuel Selector Line Inspection

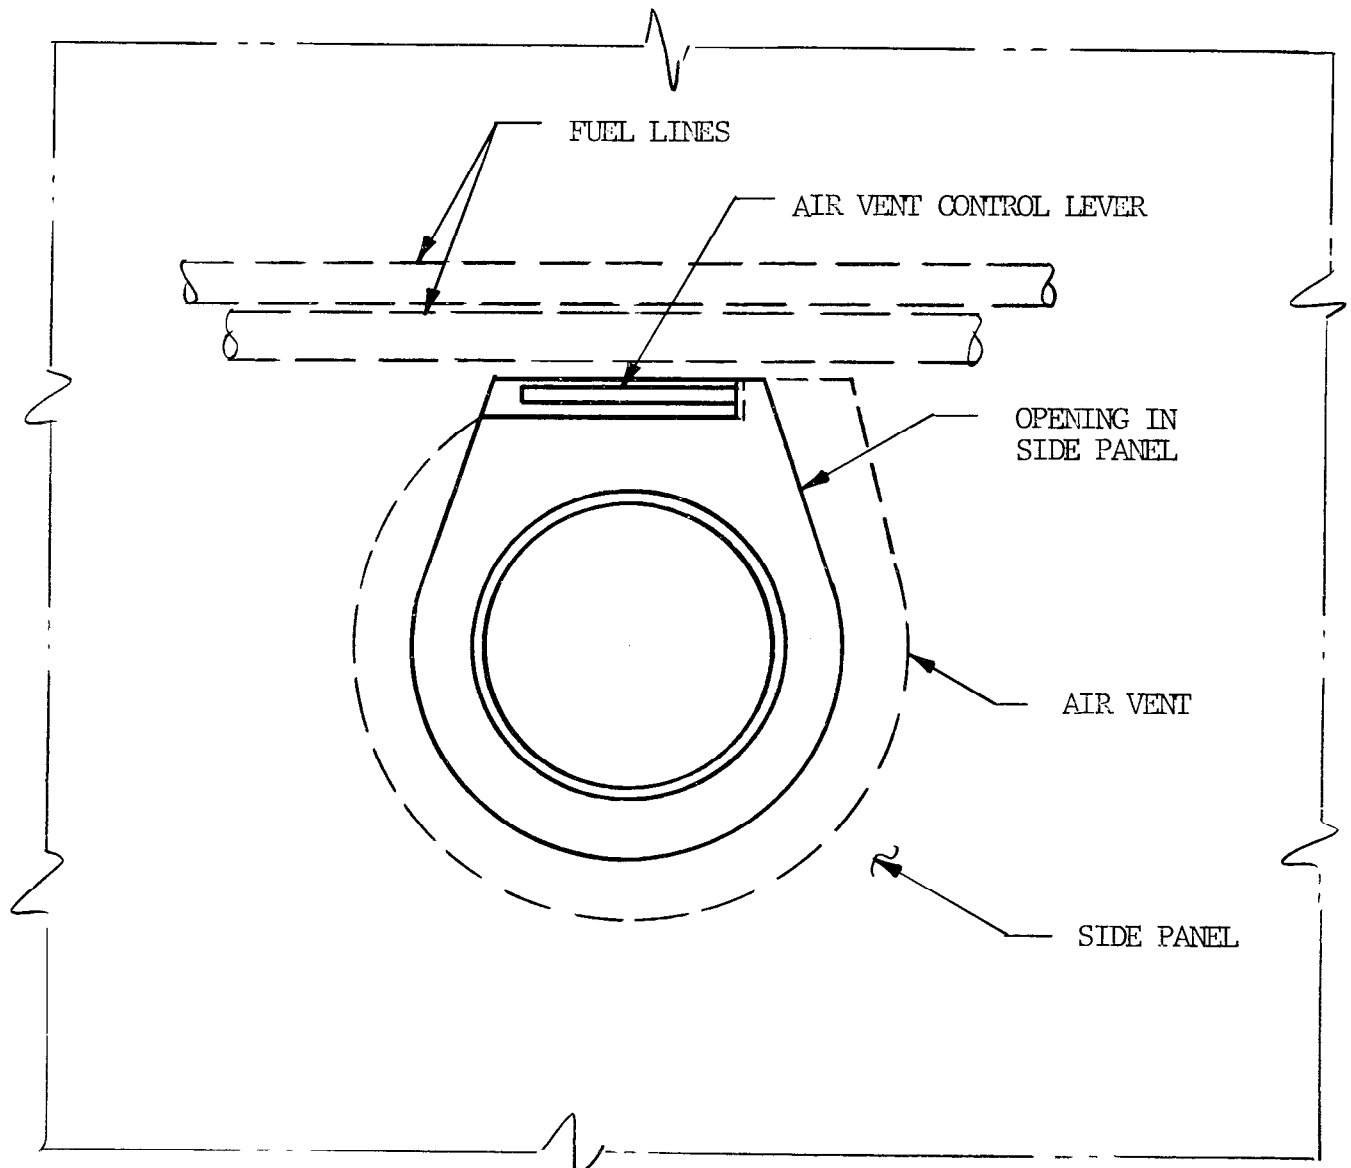
FIGURE 2

Reports have been received of a chafing condition between the left fuel line, near the fuel selector, and the left forward air vent assembly lever.

If this condition exists and is left uncorrected, the chafing could become severe enough to wear through the fuel line and cause fuel leakage.

1. Remove left hand forward air vent cover.
2. Inspect for clearance between fuel line and air vent lever. (See Figure 2). It will be necessary to rotate vent lever from open to close position to ascertain clearance throughout full travel. If a minimum of .05 inch exists, reinstall air vent cover and proceed to Instruction 7.

3. If clearance is less than .05 inch, fabricate a tool (utilizing the dimensions shown in Figure 1) from a suitable non-metallic material such as wood. Insert tool between fuel line and vent lever. Slide tool forward and aft, at the same time twisting it in each direction, to obtain .05 inch to .15 inch gap.
4. Remove tool and, utilizing a suitable mirror, inspect the fuel line for damage such as dents, flat spots, etc.
5. If fuel line is worn beyond airworthy limits, remove and replace fuel line; fuel tank drainage may be necessary. (See Material Required.) Install new fuel line and assure clearance as described in Instruction 3.
6. Inspect for leaks, reinstall side panel and air vent cover.
7. Make appropriate logbook entry of compliance with this Service Release.
