Piper Aircraft Corporation

# SERVICE *No. 811A* BULLETIN

May 12, 1986

Ammeter Replacement

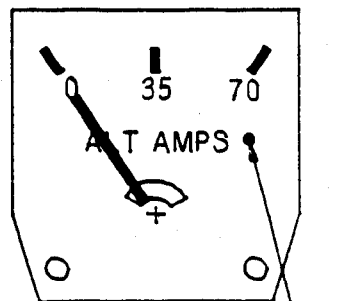
SKETCH "A"

PURPOSE: Engineering tests have determined that a number of ammeter gauges shipped in support of Service Bulletin No. 811 were not correctly calibrated. Correctly calibrated gauges may be identified by the presence of a white dot located on the righthand side of the ammeter face, immediately following the word "AMPS". See Sketch "A" attached. Incorrect ammeter indications could lead to inadvertent overcharging and/or depletion of the aircraft's battery with subsequent loss of battery electrical power.

AMMETER THAT HAS NOT  
BEEN CALIBRATED.  
NOTE ABSENCE OF IDENTIFICATION DOT

AMMETER THAT  
HAS BEEN CALIBRATED

IDENTIFICATION DOT

1. All aircraft which have complied with Service Bulletin No. 811 must inspect for the presence of a white dot on the righthand side of the ammeter face. See Sketch "A" attached.
2. If white dot is not present, the ammeter gauge, only, must be replaced with a correctly calibrated gauge.
3. Using applicable instructions for the Ammeter Replacement Kit, Piper Part Number 765-186, replace the newly installed ammeter only, with Ammeter, Piper Part Number 763-053.
