SERVICE No. 977 BULLETIN

DATE: December 12, 1994

Inspection of Wing Rear Attach Fitting and Addition of Inspection Access Panels.

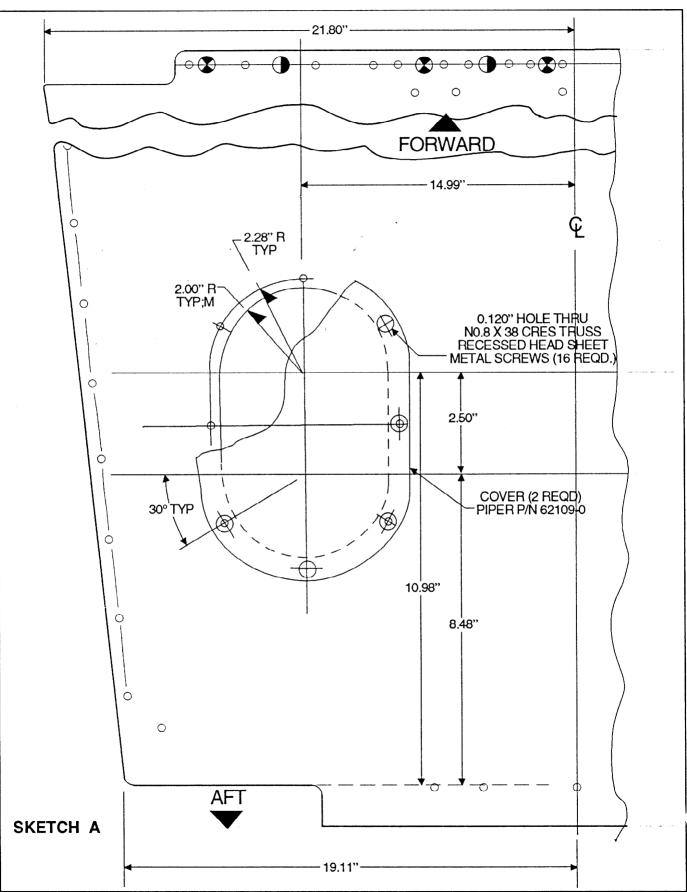
While Sketch A shows the hole in the left side of the baggage compartment, a similar hole is also cut out in the right side baggage compartment floor. Installation will require two each inspection access covers, Piper P/N 62109-0. (If desired, these covers may be fabricated locally.)

- a. Layout cut lines
 - (1) Gain access to baggage compartment.
 - (2) *Carefully* remove:
 - (a) Right side baggage compartment Royalite plastic close out panel.

- (b) Rear close out panel.
 - (c) Carpeting from baggage compartment floor.
 - (3) Determine and mark a reference center line running through baggage compartment. Refer to Figure Sketch A for measurements.

- (4) Measure two points 14.99 inches each side of the reference centerline. Joining these two points will form the centerlines of each inspection hole.

- (5) Measure two points on each side of each centerline of both holes at distances of 8.48 inches and 10.98 inches from the aft edge of the baggage compartment floor.

- (6) Connect the two 8.48" points and the two 10.98" points so that the resulting lines cross the centerline of each hole.
 - (7) Using the intersection of the lines constructed in step (6) with each hole's centerline as the center, scribe an arc having a radius of 2.00"

- (6) Draw a line (four lines total) tangent to the each side of the area constructed on step (7).
 - (9) There should now be two ovals, like the one in Sketch A, laid out on each side of the baggage compartment floor.

- (1) Drill a 1/4 inch hole inside of, and adjacent to, one of the scribed lines layed out for each hole.
- (2) Using a 1/8 inch router bit, cut out the two inspection holes by following the lines layed out on each side of the baggage compartment floor.
- (3) Deburr each cut edge using a file or emery wheel.
- c. Installing covers.
 - (1) Lay one of the 62109-0 covers over one of the inspection holes. Using the screw holes in the cover, scribe the position for the screw holes on the baggage compartment floor.
 - (2) Drill a 0.120 inch hole in baggage compartment floor at each position layed out in step (1).
 - (3) Attach cover to flooring with No.8 X 0.38 corrosion resistant steel sheet metal screws.
 - (4) Repeat steps (1) through (3) on remaining hole.
- d. Install baggage compartment rear and side close out panels.
- e. Install baggage compartment floor rug.

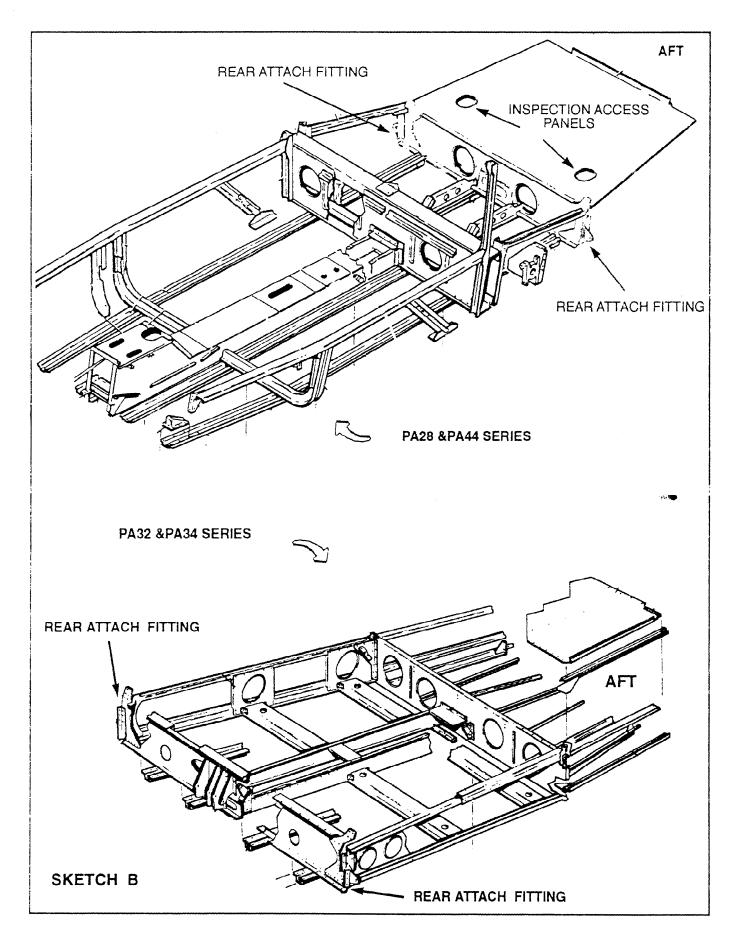
7. Locate and drill two each .191 inch drain holes, one beneath each rear attach fitting as shown on Sketch C. *NOTE*: When drilling from outside, use a drill stop set to 1 / 8 inch to advert possible interior damage.
