The New Piper Aircraft, Inc.
2926 Piper Drive
Vero Beach, Florida, U.S.A. 32960

SERVICE No. 1037 BULLETIN

DATE: October 28, 1999

Inspection for Gascolator Bowl Drain
Security

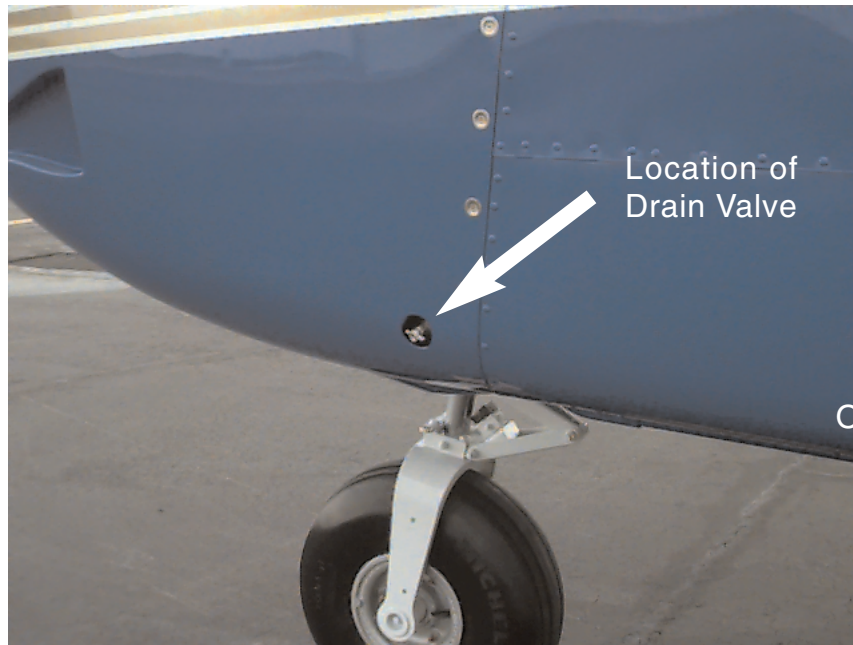
Fig. 1

1. Prior to next flight, refer to the Pilot's Operating Handbook (POH) Section 7, locate and assure the aircraft fuel selector is in the on position with the mixture in cutoff. Turn on the aircraft battery master switch and engage the electric fuel pump switch. Examine the drain valve located on the gascolator bowl just forward of the firewall for leaks or evidence of fuel seepage around the seal nut. Turn off the fuel pump and the master switch.
2. Apply moderate pressure to rotate the drain valve in a counter clockwise direction, check to see if the drain valve is loose. (See Fig. 1.) If the drain valve is not loose and there are no fuel leaks, flight operations may continue until the next maintenance event but not to exceed the next fifty hours time in service. An appropriate logbook entry of compliance with instruction 2 must be made prior to next flight.

Typical Gascolator Bowl Location

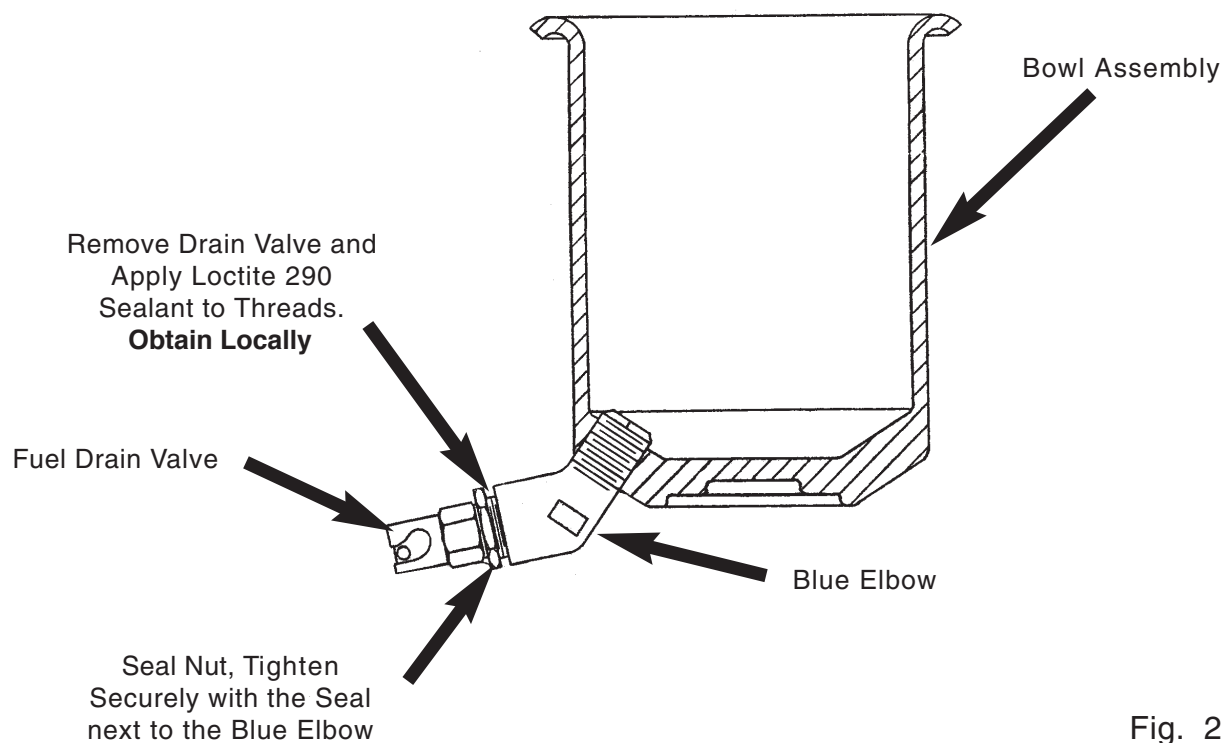
Fig. 2

It has been discovered that the drain valve located on the gascolator bowl just forward of the firewall may loosen due to usage. The drain valve is secured in a redundant manner using a seal nut tightened properly and by use of a chemical locking agent applied to the threads of the valve. The chemical locking agent was inadvertently left off, consequently there exists the potential for the drain valve to loosen and leak should the seal nut torque be compromised during ground use. Left uncorrected, fuel may leak into the engine compartment or overboard presenting a fire hazard and possible fuel starvation.

Gascolator Bowl Detail

3. If the drain valve is loose/leaking or if the appropriate maintenance time has been achieved, immediate action must be taken.
4. Turn the fuel selector to the off position and drain the residual fuel from the gascolator bowl. Loosen the seal nut and remove the drain valve. (See Fig. 2.)

5. Remove the seal nut from the drain valve. Clean the threads of the drain valve, seal nut, and the blue elbow attached to the gascolator bowl. Install the seal nut on the drain valve as far as possible with the seal facing the thread end. (See Fig. 2.) *Note: If drain valve was leaking out of the drain and not the connection, replace the drain valve before proceeding.*

6. Use Loctite 290 per the manufacturers directions. Apply a one drop coating evenly to the 2nd, 3rd and 4th threads of the drain valve. Do not allow Loctite to enter the fuel system. Install the drain valve until tight. Holding the drain valve, tighten the seal nut firmly against the blue elbow with the seal fully engaged.
