SERVICE NO. 1131A BULLETIN

Date: January 18, 2016

**INSPECTION OF 'CAST' MAIN LANDING GEAR
STRUT CYLINDERS**

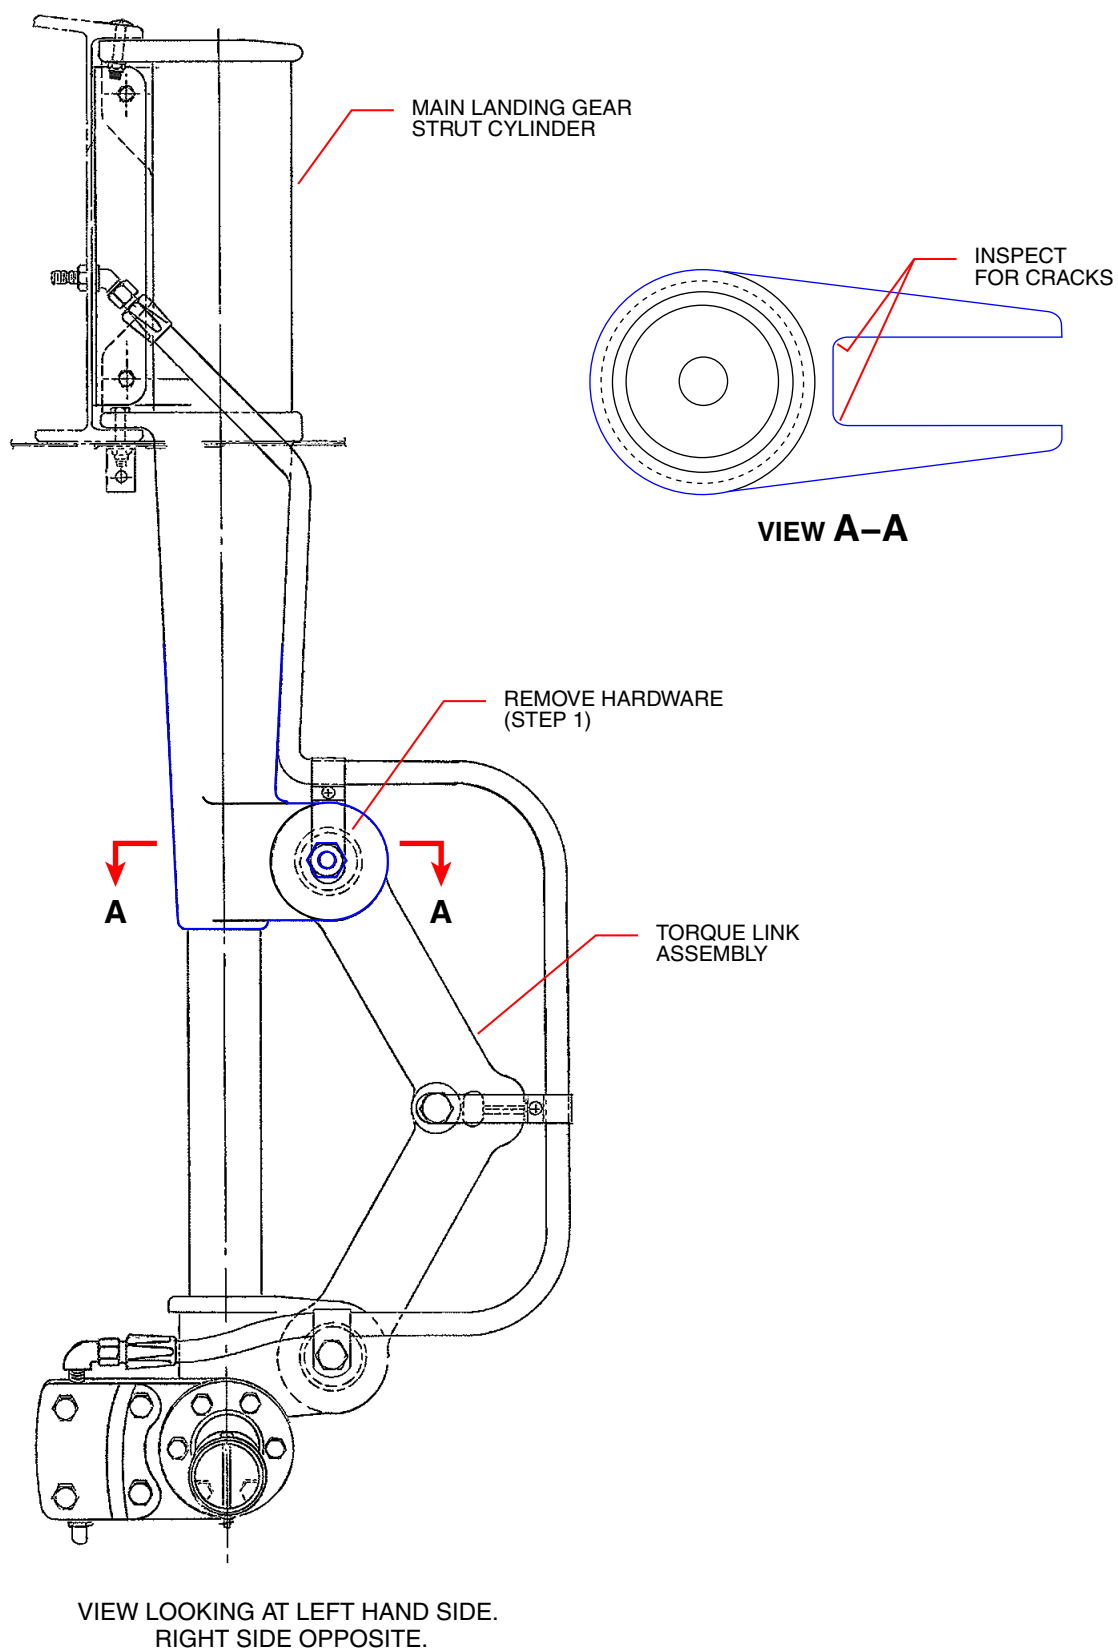
Figure 1
Inspection Area

1. Disconnect the torque link assembly by removing the cotter pin, nut, washers and bolt at the location indicated in Figure 1. Discard the cotter pin. Note the arrangement of all hardware, including shims and spacers, for reinstallation. To provide access for this inspection, rotate the torque link assembly away from the torque link attach lugs.

2. Thoroughly clean the area to be inspected as indicated in Figures 1 and 2, using a suitable cleaner.
3. Using a 10X power magnifying glass, visually inspect the radii of the main landing gear strut cylinder's torque link attach lugs for cracks. Refer to Figures 1 and 2 for the inspection locations. If no cracks are found by visual inspection, proceed to liquid penetrant inspection per Chapter 5, Section 5, of FAA Advisory Circular AC 43.13-1B, to check for cracks. Strip the paint and primer from the areas to be inspected using a commercially available chemical paint stripper, taking care to only remove paint and primer from the inspection areas.

4. If a crack is detected, prior to further flight replace the “cast” main gear strut cylinder with the “forged” main gear strut cylinder per the applicable Piper Airplane Maintenance Manual (see Material Required, below, for the appropriate part number to order).
