SERVICE *No. 1139A* BULLETIN

Date: April 9, 2004

**CONTROL WHEEL ATTACHMENT INSPECTION &
RETAINER CLIP INSTALLATION**

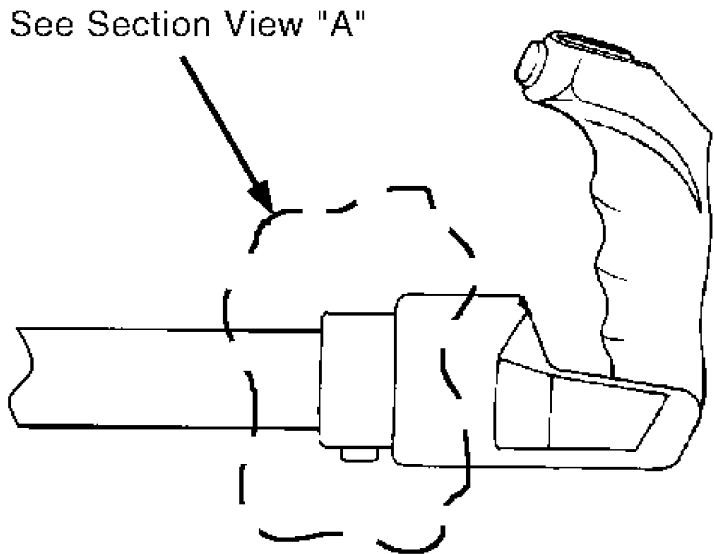
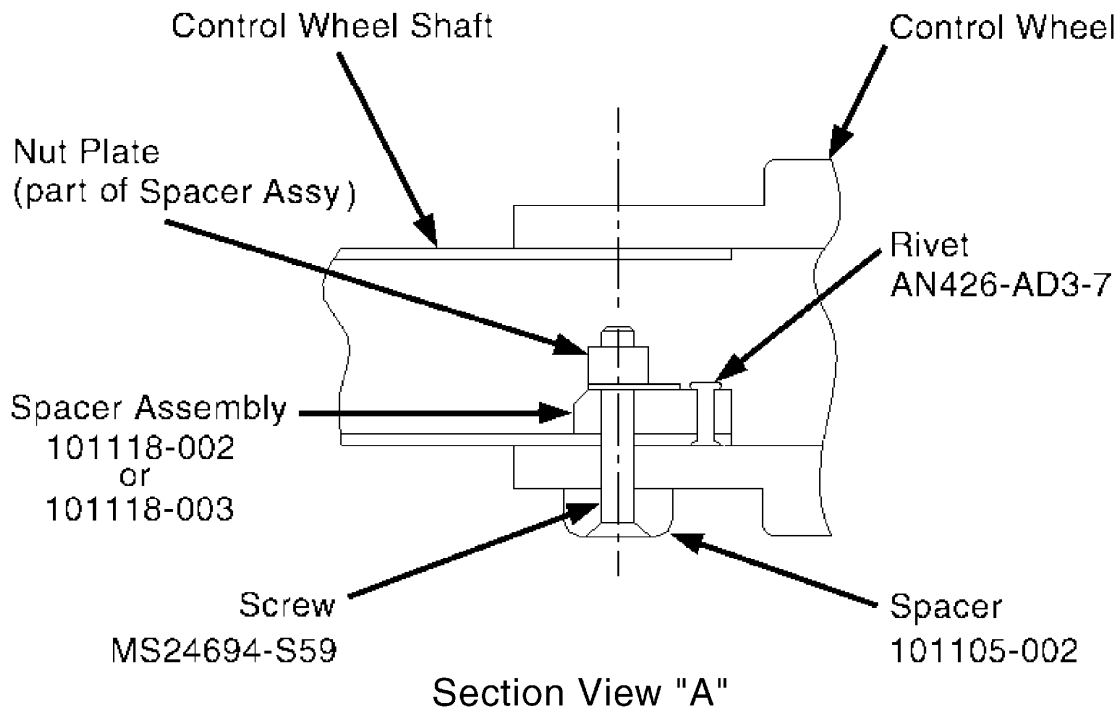
Control Wheel Attachment Inspection
Figure 1

A report from the field has been received of a pilot side control wheel separating from the control wheel shaft resulting in loss of control of the aircraft from the pilot seat location. The incident occurred on a 2002 model, PA-28-181 Archer III aircraft that utilizes the modern control wheel introduced in all New Piper production models in early 1998. The method of attachment of the control wheel to the shaft was changed at the time of introduction of the new control wheel and this publication is applicable only to those aircraft that utilize this new type of control wheel. This Service Bulletin requires a one time inspection of the control wheel attaching hardware for proper installation, addition of Loctite thread locking compound to the screw installation, and installation of a secondary mechanical locking device (a retainer clip) to the control wheel attachment.

- b) Inspect the end of the screw, P/N 410-046, (MS24694-S59) that secures the control wheel to the shaft for proper thread engagement through the nut plate (minimum 1 thread showing past the end of the nut plate).

- c) Re-install the screw into the nut plate located within the control wheel shaft and attempt to fully tighten the screw by hand (without the aid of a screwdriver). If the screw can be fully inserted into the nut plate by hand (one thread past the end of nut), then replacement of the nut plate is required. The nut plate is part of the spacer assembly P/N 101118-002 (On PA-46-350P & PA-46-500TP) or P/N 101118-003 (on all other models). If replacement is required, carefully drill out the rivet, P/N 420-706 (AN426-AD3-7), securing the spacer assembly to the control wheel shaft to remove the spacer assembly. Order and install a new spacer assembly P/N 101118-002 (On PA-46-350P & PA-46-500TP) or P/N 101118-003 (on all other models) and secure to the control wheel shaft using rivet, P/N 420-706 (AN426-AD3-7).

- c) If insufficient thread engagement is found, replace the screw with the next longer screw, P/N 410-047 (MS24694-S60) during re-assembly.
2. Check the nut plate for sufficient locking characteristics as follows:

- a) **Thoroughly clean the nut plate on the spacer assembly (P/N 101118-002 or -003), the screw (P/N MS24694-S59 or -S60), and the spacer (P/N 101105-002) with acetone or similar solvent to ensure the parts are thoroughly degreased for application of Loctite thread locking compound.**
- b) Re-install the control wheel onto the control wheel shaft and line up the screw hole in the wheel to the hole in the shaft.

- c) Apply Loctite Primer #7649 and Loctite thread locking compound #271 to the screw threads per the manufacturer's instructions and install the screw, 410-046 (MS24694-S59) or 410-047 (MS24694-S60) and the spacer, P/N 101105-002. Tighten the screw until fully seated.
- d) Re-install the Piper logo medallion, P/N 474-364, and secure to the control wheel using the 2 upper allen head cap screws, P/N 520-025 (NAS1352-06-12), previously removed (lower cap screws to be replaced per Part II).
