# SERVICE **No. 1141** BULLETIN

Date: December 9, 2003

### **CLIP NUT REPLACEMENT**

PA-28-161 Warrior III  
PA-28-181 Archer III  
PA-28R-201 Arrow  
PA-32R-301 Saratoga II HP  
PA-32R-301T Saratoga II TC  
PA-34-220T Seneca V

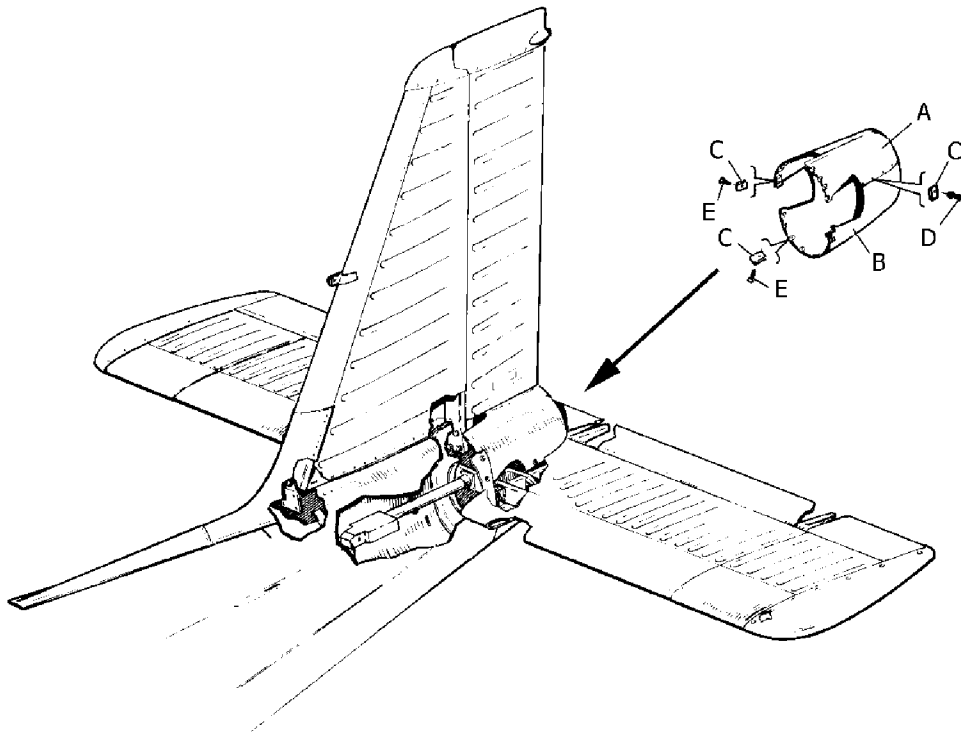
Typical Tail Cone  
Figure 1

It has been discovered that the above noted aircraft were delivered with tail cone fairing attachment clip nuts installed that did not incorporate a thread locking feature that prevents the fairing mounting screws from loosening and backing out. If the screws were to loosen and fall out, the displaced fairing may interfere with the operation of the horizontal stabilator.

1. Remove the 16 screws, P/N 415-378, (MS51957-45) (Figure 1, Item E) securing the tail cone fairings to the aft end of the fuselage. Remove the 10 screws, P/N 410-054, (MS24694-C5) (Figure 1, Item D) securing the upper tail cone fairing (Figure 1, Item A) to the lower tail cone fairing (Figure 1, Item B).
2. Remove and replace the 26 clip nuts, P/N 477-640, (Figure 1, Item C) from the fuselage and the upper and lower tail cone fairings, ensuring that the replacement clip nuts have a 'thread locking' feature.
3. Reassemble the upper and lower tail cone fairings and re-install the tail cone fairing using the appropriate screws previously removed.
4. Make a logbook entry indicating compliance with this Service Bulletin.
