SERVICE *No. 1199* BULLETIN

Date: February 16, 2009

MAIN LANDING GEAR TORQUE LINK INSPECTION

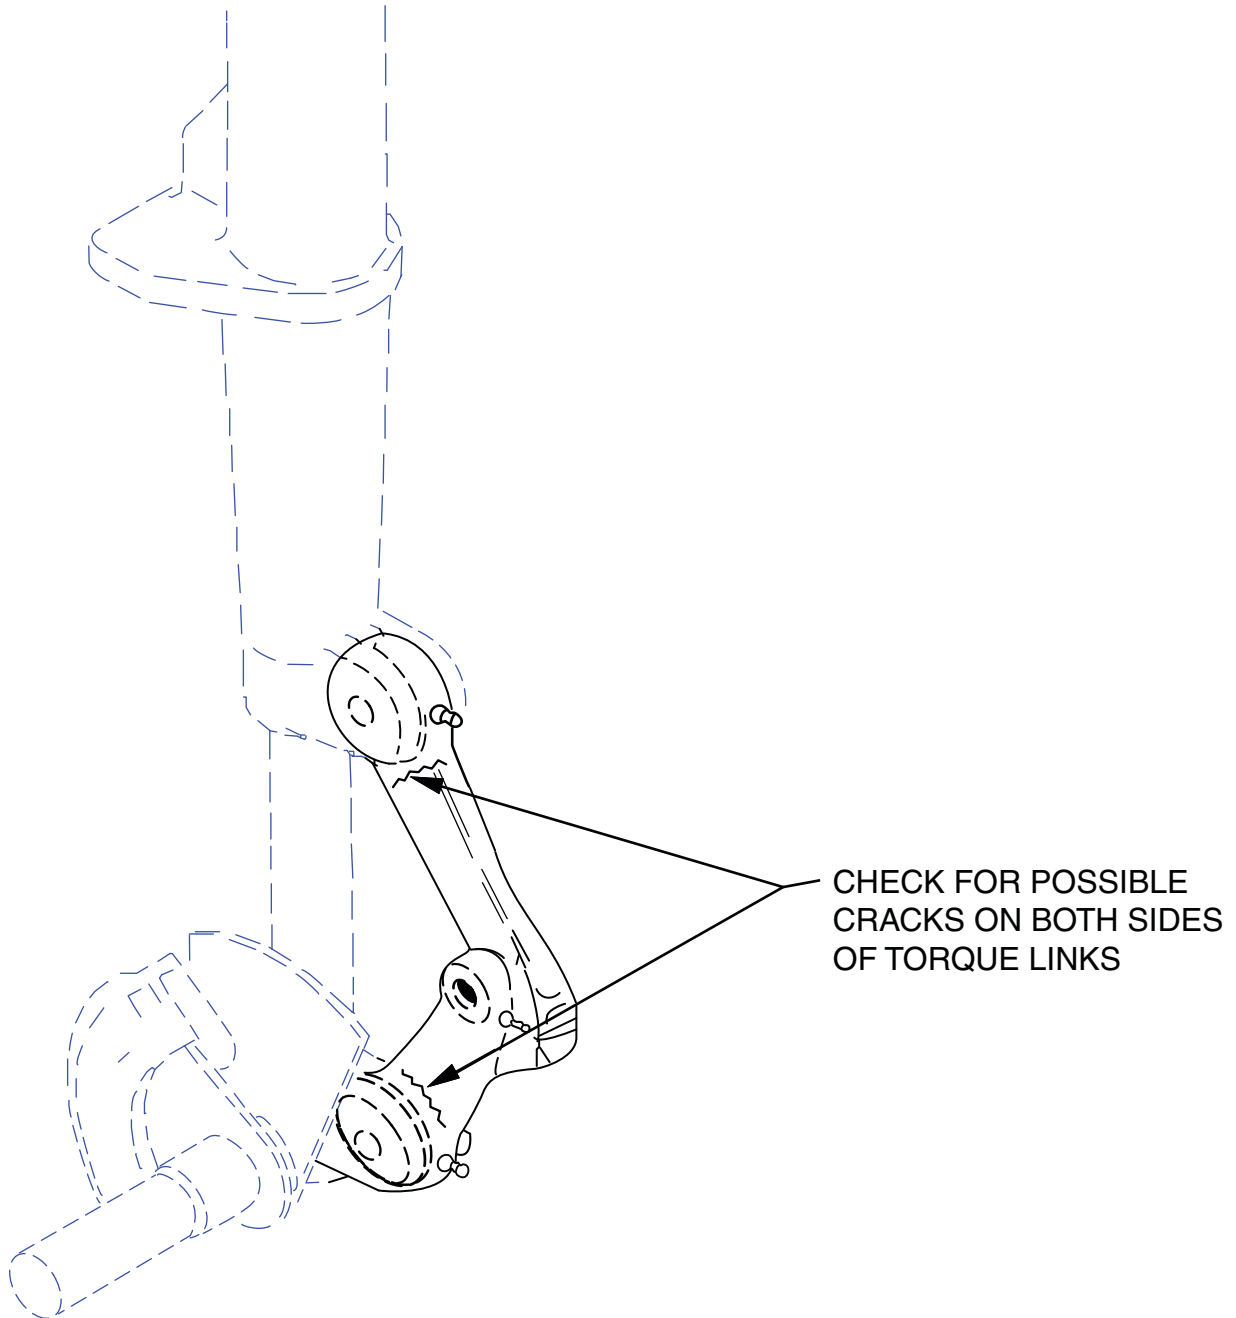
1. Locate the torque links, which are a component of the main landing gear, both left and right sides. There are a total of 4 torque links per aircraft. See Figure 1.

1. Place the aircraft on jacks and remove the main landing gear wheel assemblies in accordance with the Aircraft Maintenance Manual.
2. Remove paint from the area to be inspected, at the locations identified in Figure 1. (Use Cee-Bee A-202 paint stripper or equivalent).

Location of Torque Links and Inspection Area

3. Use isopropyl alcohol to wipe clean the area of the torque links where paint was removed.
4. Perform fluorescent penetrant inspection of the areas identified in Figure 1 per AC 43.13-1B.
5. If a crack is detected in any torque link, the torque links must be replaced in pairs, using the new style 78033-000 torque links. See MATERIAL REQUIRED section of this service bulletin.
6. If no crack is detected during the inspection, wipe torque links clean with isopropyl alcohol.
7. Apply primer to Torque links in area where paint was removed for inspection; using MIL-PRF-85582D Type I Class C2 primer; ANAC 10P8-10 Fluid Resistant Epoxy primer or any compatible epoxy primer. Apply top coat of paint using Dupont White (color code N00009 HN) Imron 5000-Texture A (smooth finish).
8. Reinstall main wheel assemblies.
9. Remove jacks from aircraft.

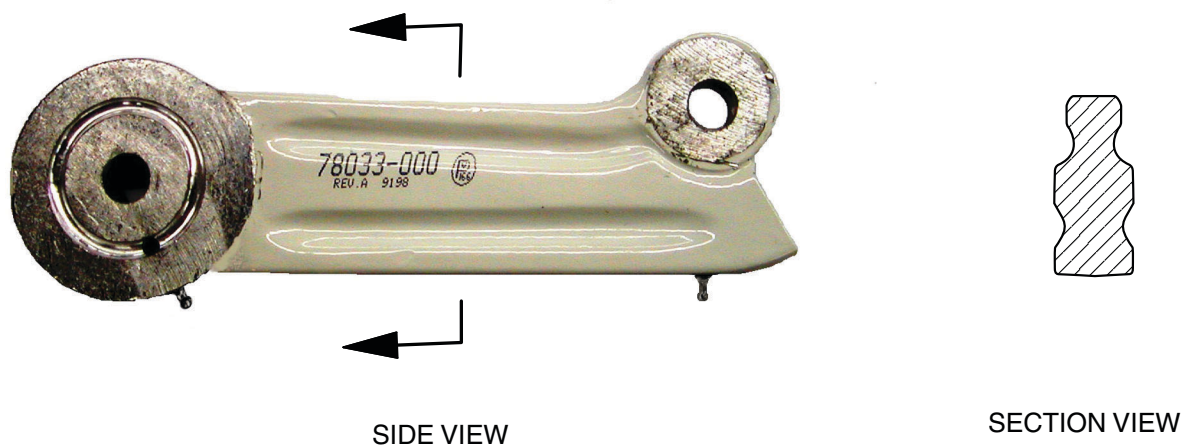
Figure 2
New Style Torque Link 78033-000

2. Determine which torque links are currently installed.
 - Figure 2 shows the new style torque link, Piper part number 78033-000. The midsection of this new style torque link is rectangular in cross section, with 4 longitudinal grooves (2 per side), as shown in the section view of Figure 2. The new style 78033-000 torque link is exempt from the recurring inspection requirement of Service Letter 600 and this Service Bulletin. Proceed to **Part III** if all four (4) torque links are the new style, Piper part number 78033-000.
