Induction Airbox Air Valve Bushing Improvement

PA-28-181 Archer III

2890206 through 2890231, 2843001 through 2843237

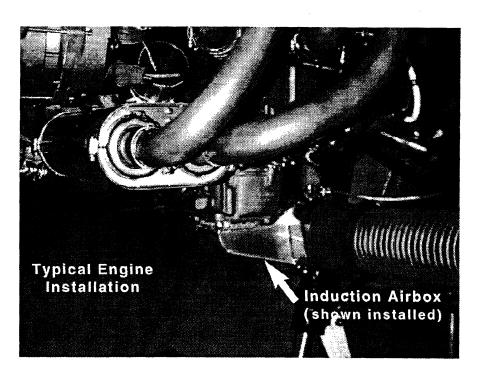
PURPOSE: It has been discovered that the bushings and grommets which support the induction airbox air valve are wearing quickly necessitating early repair. This condition has been remedied by an improved design of the bushings and replacement of the existing induction airbox air valve. Left uncorrected, this condition over time may allow the induction airbox air valve to come loose and wear into the airbox housing, which may require expensive repairs or airbox replacement.

- 1. Install the Induction Airbox Modification kit, Piper Part Number, 766-666. Only one kit is required per aircraft. All of the necessary instructions and materials for successful modification of the induction airbox are contained in the kit. See Fig. 1 & 2 for reference.
- 2. Perform an engine ground run per the appropriate chapter of the applicable Maintenance Manual to assure engine performance. Correct as required.
- 3. Make an appropriate logbook entry indicating compliance with this Service Letter.
