SERVICE *No.* 1066 LETTER

MAINTENANCE ALERT

IGNITION HARNESS ROUTING INSPECTION

PA-28-181 Archer III

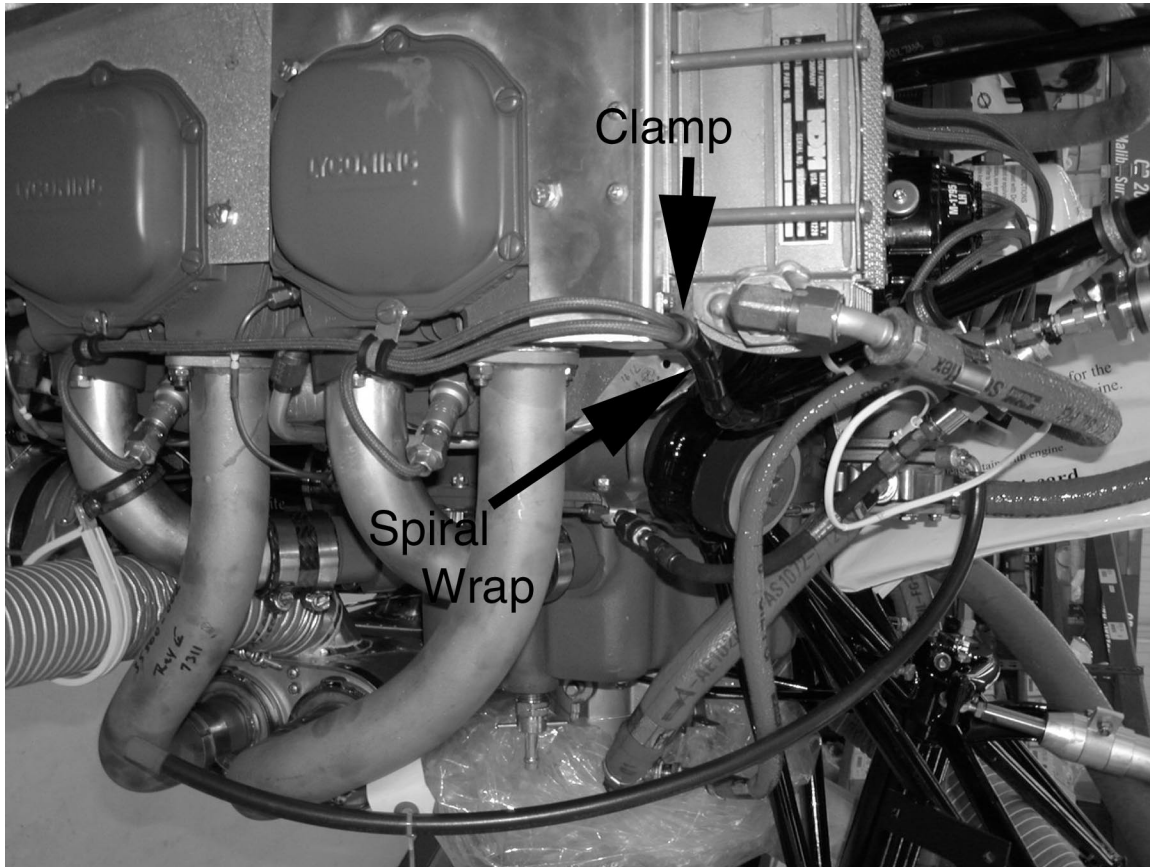
Figure 1
Spiral Wrap Location between Clamp and Ty Wrap on Engine Mount

It has been discovered that the ignition cables shown in Figure 1 are sometimes improperly secured when they have been removed for maintenance. If these cables are improperly routed and secured upon re-installation, they may interfere with the oil cooler.

If the condition is left uncorrected it may cause damage to the ignition cables.

This letter adds a strip of spiral wrap to provide additional protection for the ignition cables if the spiral wrap is missing.

1. Remove upper engine cowling. Check the ignition cables and clamp indicated in Figure 1. Ensure the cables do not contact or rub against the oil cooler.
2. If the ignition cables are interfering with the oil cooler or they are not properly routed, inspect for damage, reroute and secure correctly.
3. Check for the protective spiral wrap. If the spiral wrap is missing, install an eight (8) inch strip of spiral wrap around the ignition wires from the clamp toward the magneto.
