## VENDOR SERVICE PUBLICATION

SUBJECT: Oil Pump Impeller and Drive Replacement; AVCO Lycoming Service Bulletin No. 385C dated October 3, 1975 (attached).

Service Bulletin No. 385C  
(Supersedes Service Bulletin No. 385B)  
Engineering Aspects are  
FAA (DEER) Approved

SUBJECT: Oil Pump Impeller and Drive Replacement

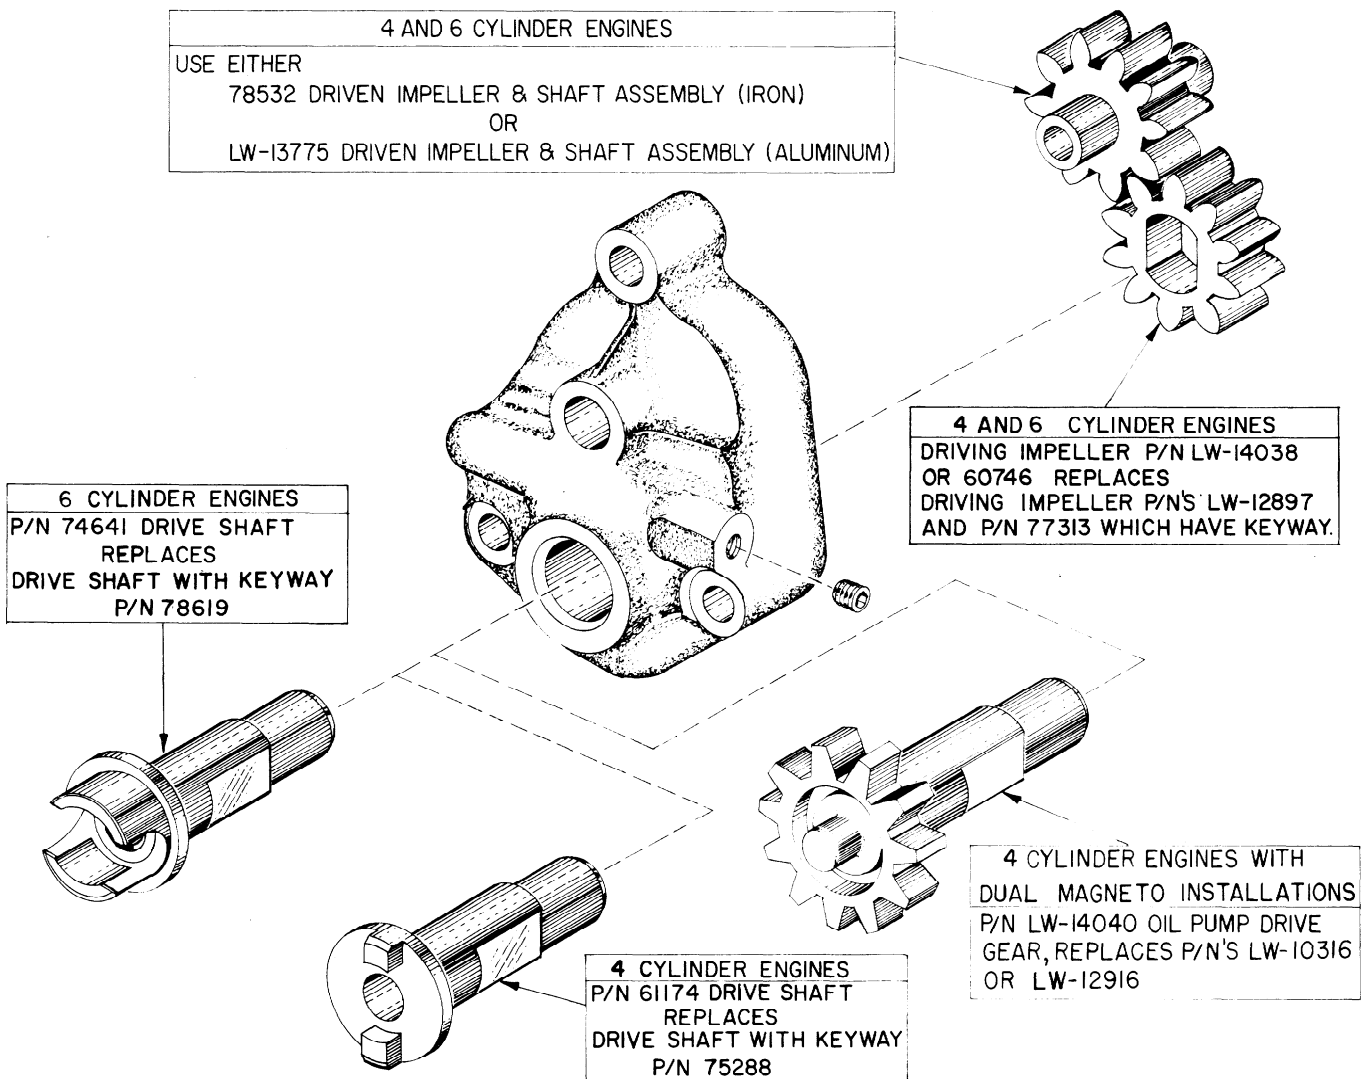
Figure 2. Oil Pump Drive Assembly

This modification consists of replacing the oil pump drive shaft and drive impeller to eliminate the Woodruff key drive which has proven to be the cause of excessive wear in the keyway of the hardened drive impeller. Therefore, it is recommended that all of the applicable engines listed in the chart, as well as any others that may have been modified in accordance with Service Instruction No. 1272, use the following procedure for parts replacement.

3. Reassemble the oil pump using the new drive shaft and drive impeller supplied with the kits shown in the following "Parts Data" section. See figure 2. Be sure all of the parts are lubricated thoroughly during assembly.
