VSP-30  
May 20, 1981

VENDOR SERVICE PUBLICATION

Subject: Bendix Service Bulletins 599A, 609A, 610,  
613, 614

**SERVICE BULLETIN NO. 599A**  
(Supersedes Service Bulletin No. 599)  
Engineering Aspects are  
FAA Approved

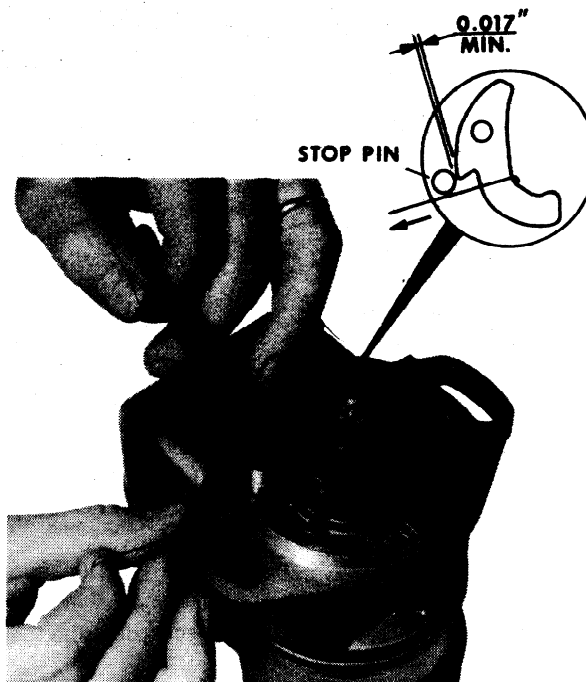
Figure 2. Checking Flyweight to Stop Pin Clearance

c. While pulling flyweight outward, insert feeler gages to measure the clearance between the heel of the flyweight and the stop pin, assuring a minimum of 0.017 inch exists.

d. If less than 0.017 inch clearance exists, this is cause for immediate rejection of the impulse coupling cam assembly, or possibly the entire impulse coupling. Refer to the applicable Magneto Overhaul Instructions for inspection procedures to determine if other impulse coupling parts are still serviceable.

6. If the impulse coupling is found to be unacceptable as a result of any of the preceding checks described, replace the entire impulse coupling assembly or worn parts according to instructions of applicable Bendix publications.
7. When inspection of the impulse coupling assembly is being performed, the stop pins in the magneto flange or housing must also be examined. Visible damage or wear in the area where the flyweight contacts the stop pin is cause for repair or replacement of the magneto, stop pin, housing or flange depending on magneto. (Reference latest revision of Bendix Overhaul Manuals Publication Forms L-205, L-645, L-945 and L-1019.)
8. When inspection procedures outlined in this bulletin have been completed, an appropriate notation must be made in the Engine Log Book referencing magneto serial number.
