VSP-37  
July 7, 1982

VENDOR SERVICE PUBLICATION

Subject: Bendix Service Bulletins 615, 620, 621

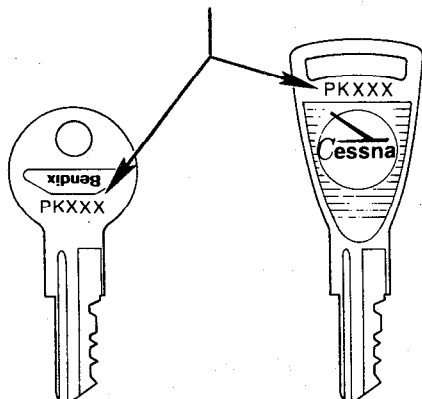
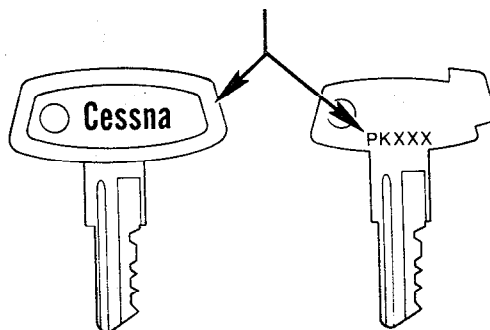
**Figure 1**

**NOTE:** The key PK number is located on the key as indicated in figure 1.

Key PK number  
stamped in this area.

Have to remove black rubber  
from top of key to expose  
the PK number.

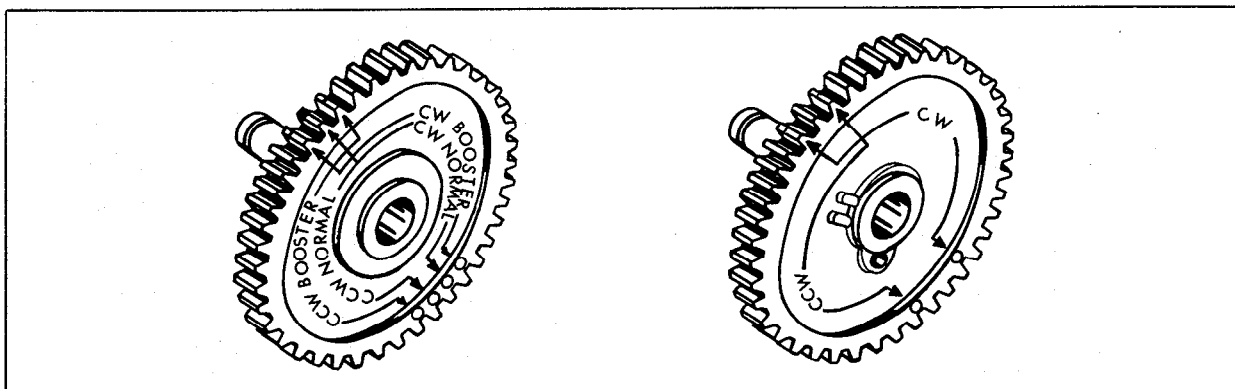
Figure 1. 10-157197 Distributor Gears with Different Timing Marks

2. If old distributor gear, P/N 10-157197, which incorporated two different molded timing identification marks was used (see figure 1), proceed as follows:

- Remove paint from booster timing positions with suitable solvent.
- Locate normal timing tooth between CW and CCW booster chamfered teeth and paint this tooth and the applicable inner timing mark with red Dykem or red lacquer in accordance with figure 2 or figure 4 for appropriate gear.

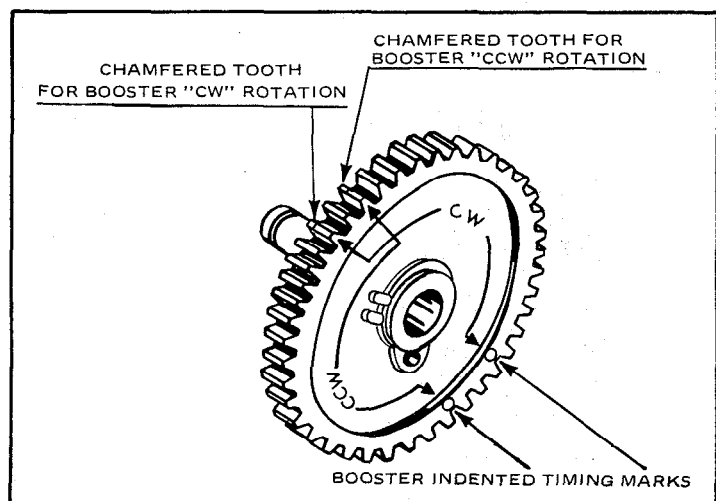
Figure 3. Timing Marks on Present Production Distributor Gear Kit Assembly 10-357586

3. If present production distributor gear as supplied in kit P/N 10-357586 is used (see figure 3) proceed as follows:

The molded timing marks incorporated in new present production nylon spare part gears, as supplied in kit, P/N 10-357586, are for the booster timing position. Before installation of a new gear kit, the applicable normal timing mark and center tooth must be marked with red

- Remove paint from booster timing positions with suitable solvent.
- Locate normal timing tooth between CW and CCW booster chamfered teeth and paint this tooth and the applicable inner timing mark with red Dykem or red lacquer in accordance with figure 4.

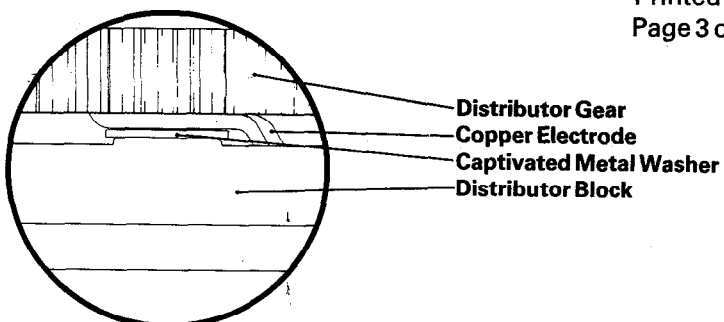
**Original Gear Make Up**  
(Not incorporating insulating or plain steel skid washer.)  
**Figure 1**

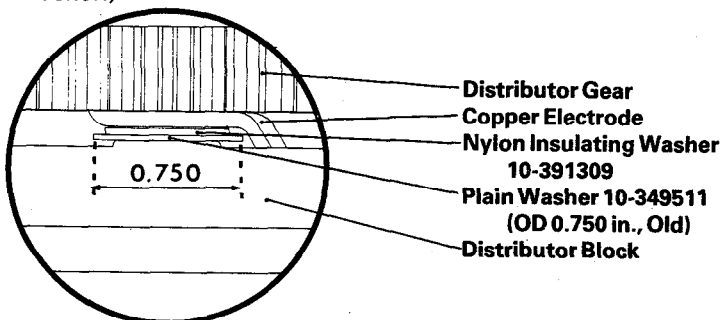
It has been determined that plain steel washer P/N 10-349511 installed on the gear axle between the nylon insulating washer P/N 10-391309 and the distributor block bronze oil-lite bushing (see figure 2) can cause electrical flash-over in the distributor at altitude. Inspect for compliance as follows:

**Insulated Gear Configuration**  
(Incorporating 10-357586 Kit parts with *incorrect* washer.)  
**Figure 2**

1. Remove the top timing plug.
2. Using a concentrated light beam (a pen light or equivalent) look into the timing hole at the area between the distributor gear and the distributor block parts for existing washer configuration.
3. Current configuration should be as shown in figure 3.
4. Rework magneto whenever configuration is as shown in figure 2.
5. An acceptable configuration is shown in figure 1.

1. Remove magneto from engine.
2. Disassemble as required using procedures described in Bendix Overhaul Manual Form No. L-205-10 for S-20 and L-527-4 for S-200 series magnetos.
3. Remove retaining ring and plain washer. Discard retaining ring. Remove distributor gear from the distributor block.
4. Inspect the distributor block for burning or carbon tracking and serviceability. Replace if defective.
5. Remove old plain steel washer P/N 10-349511 (OD 0.750 in.) and nylon insulating washer P/N 10-391309 from the gear axle.
6. Reinstall nylon insulating washer P/N 10-391309 and install new plain washer P/N 10-606505 (OD 0.562 in.) on gear axle. See figure 4 for assembly order.
7. Wipe distributor gear axle clean, then reinstall it in the block. Place plain washer P/N 10-349511

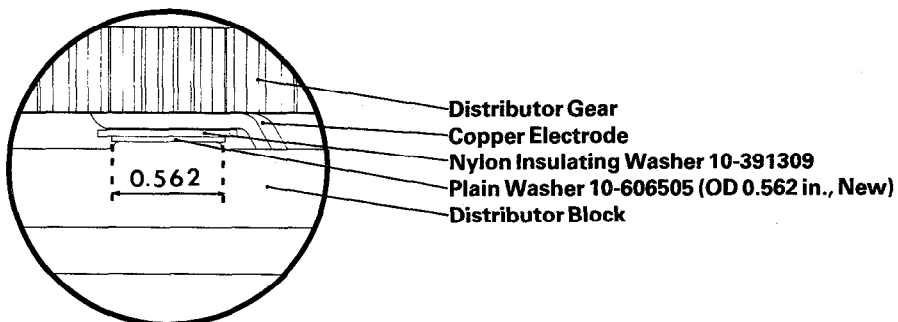
**Current Insulated Configuration**  
(Incorporating 10-357586 Kit parts with *correct* washer.)  
**Figure 3**
