VENDOR SERVICE PUBLICATION

SUBJECT: Teledyne Continental Motors Service Bulletins M85-14
and M85-16

M85-14

SUBJECT: MAGNETO PRESSURIZATION FILTER**MODELS****AFFECTED:** All Pressurized Magneto Installations**COMPLIANCE:** As Required at Next Scheduled Maintenance

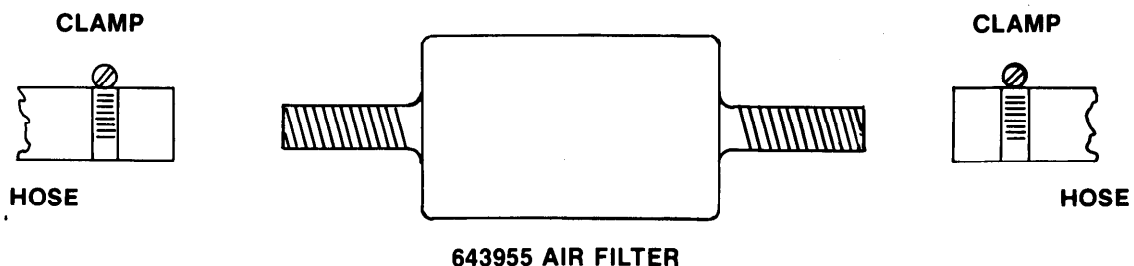
FIGURE 1. MAGNETO PRESSURIZATION FILTER

To prevent pressurization hoses from disengaging from the magneto air filter, P/N 643955, at altitude, it is recommended that at the next scheduled maintenance the following modification be performed, if not already accomplished.

Loosen both clamps as illustrated in Figure 1. Slide pressurization hoses from air filter. Holding body of filter in hand, roughen both ends of the filter with #280 grit (or equivalent) sandpaper in a clockwise direction. Wipe sanded areas clean of abrasives prior to reinstalling hoses and securing clamp. Make Log Book entry reflecting compliance.
