## VENDOR SERVICE PUBLICATION

**SUBJECT:** Textron Lycoming Service Bulletin Number 486

# SERVICE BULLETIN

Inspection of **Single Belt** Driven Ring Gear Support Assemblies

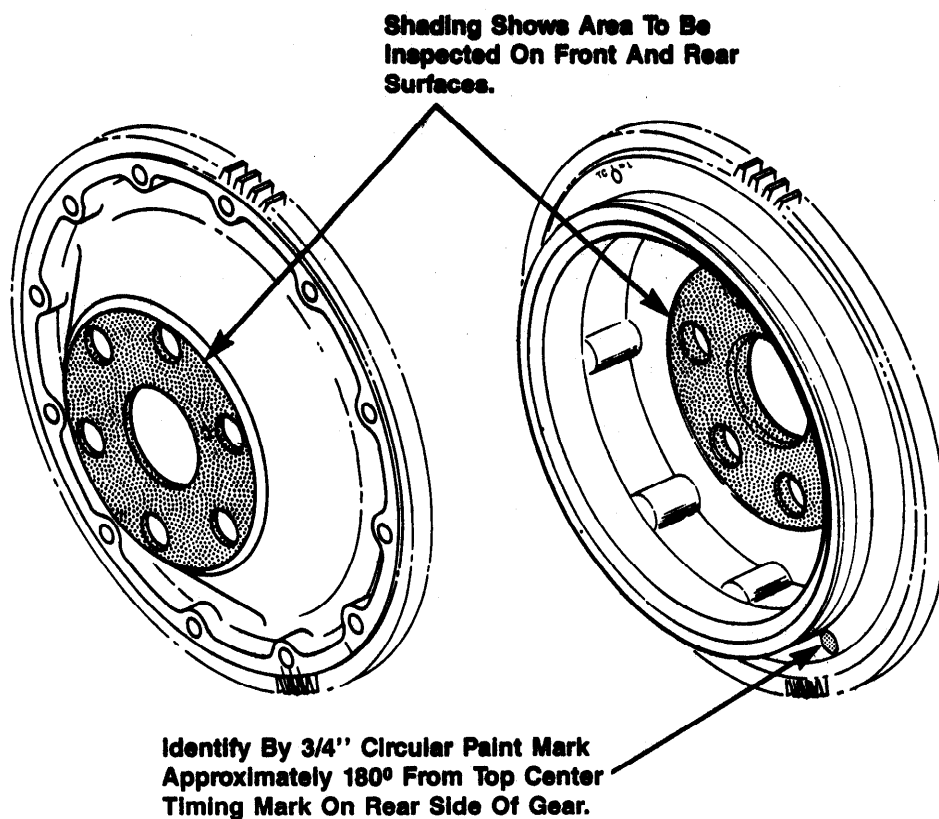
Figure 1. Starter Ring Gear Inspection Areas

It has been discovered that a small quantity of Starter Ring Gear Support Assemblies installed on engines and shipped as spares between January 1, 1988 and June 12, 1989 may exhibit one or more cracks on the front and/or rear machined surfaces. The crack or cracks may appear at any point on the surfaces mating with the crankshaft/propeller flange. See Figure 1, Page 5.

After removal of the starter ring gear support, inspect the support assembly in the areas shown in Figure 1, Page 5, using a dye penetrant to insure no cracks are evident. Follow the penetrant manufacturer's instructions to perform the inspection.

If a crack is evident, the starter ring gear support assembly must be returned to Textron Lycoming through an authorized Textron Lycoming distributor for warranty consideration.

If no cracks are found, the starter ring gear support assembly must be identified with a yellow circular paint mark approximately 3/4 inch in diameter located 180 degrees from top dead center mark on the rear side of the support assembly. See Figure 1, Page 5.
