SERVICE No. 977 BULLETIN

DATE: December 12, 1994

Inspection of Wing Rear Attach Fitting and Addition of Inspection Access Panels.

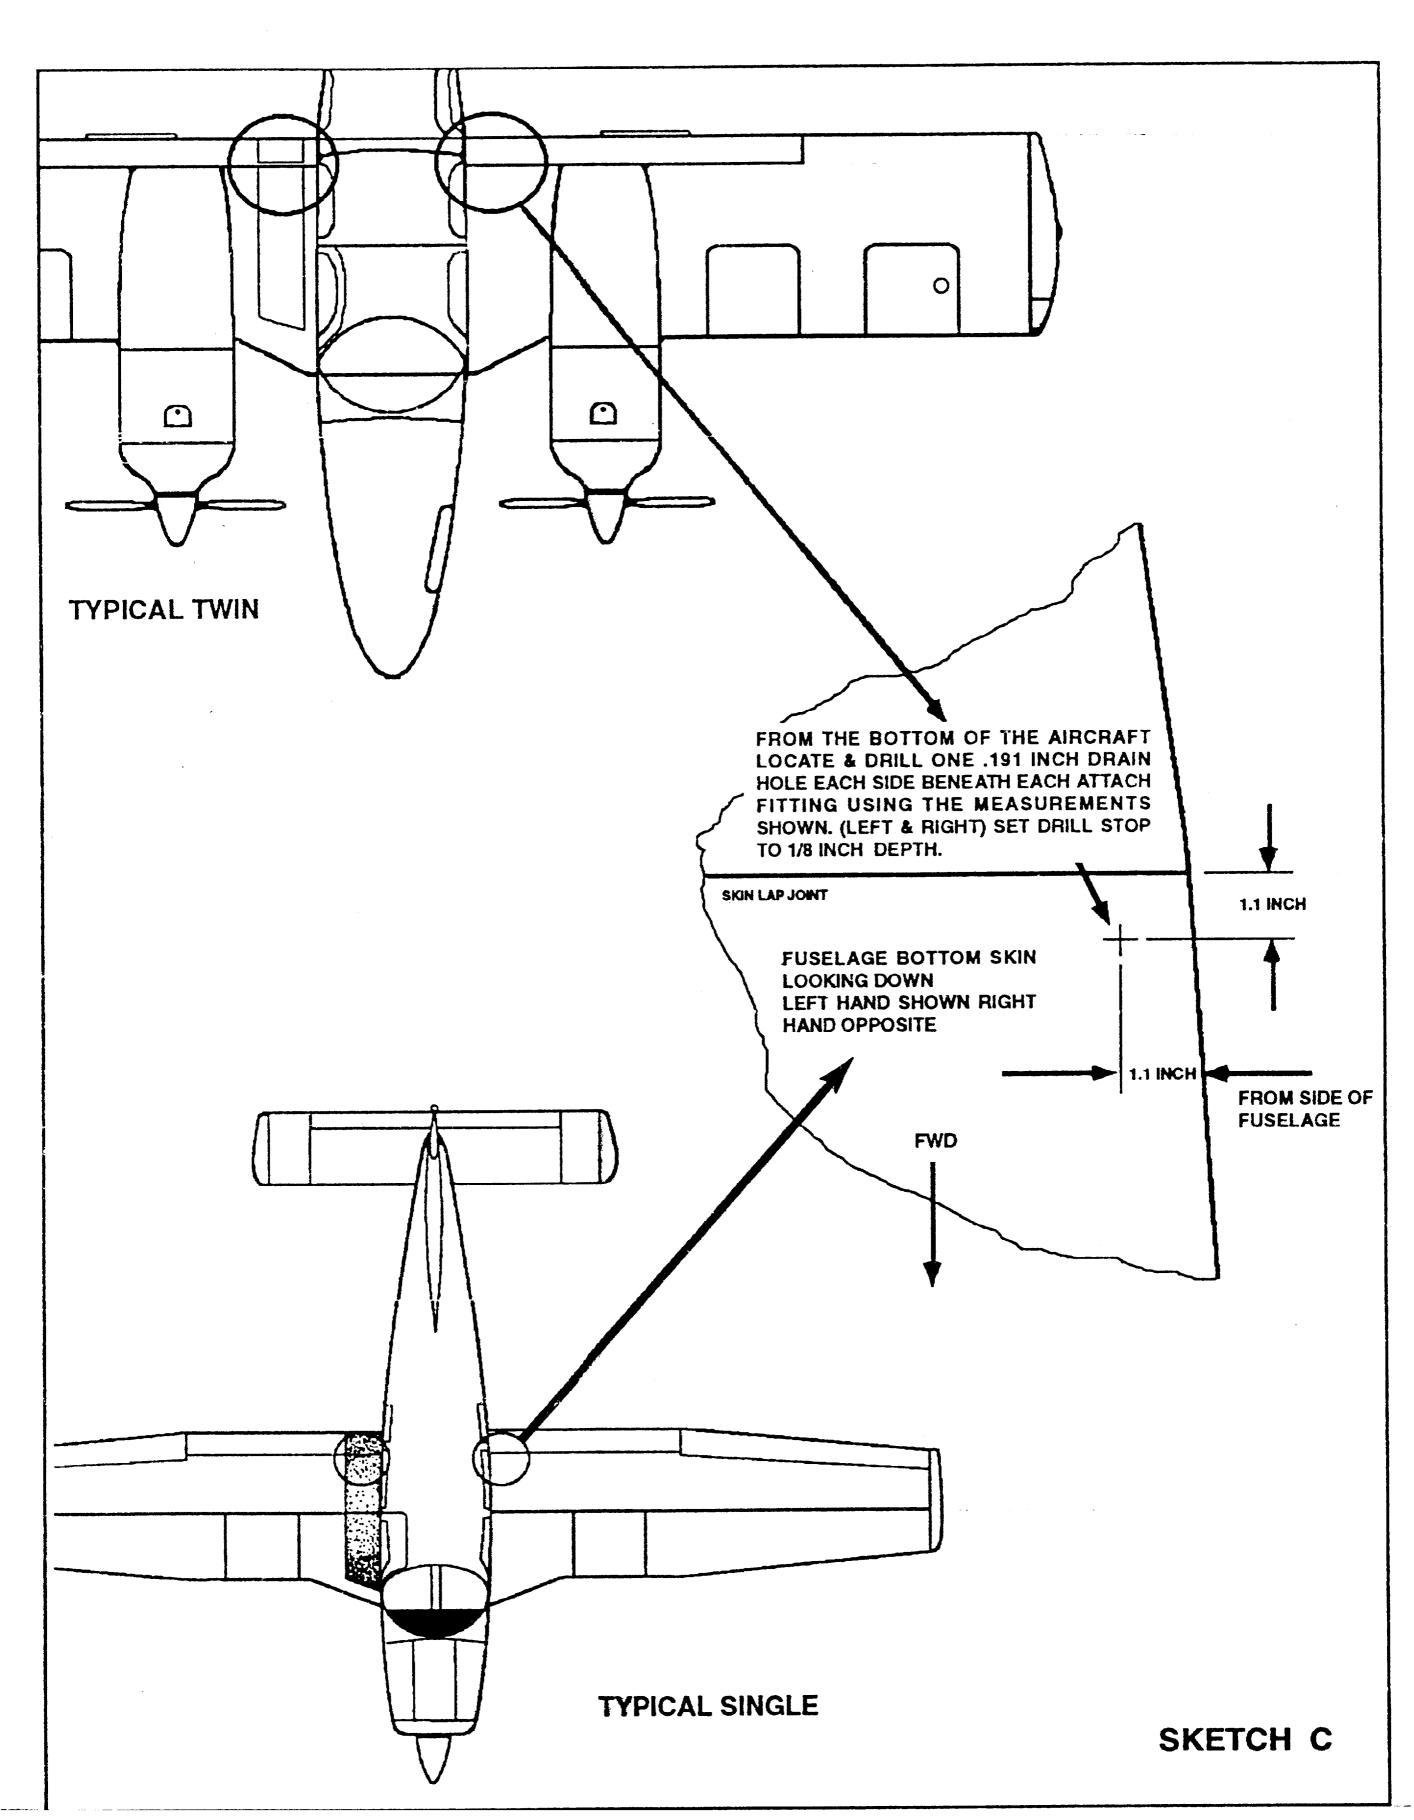
For hard to reach areas. It is permissible to replace the existing MS20470AD-5 rivets with HI Lok fasteners. Use HL30-5 with HL-94 HI Lok collars. Torque to 15 to 25 inch lbs. Observe standard practices for use of HI Lok fasteners.
