VSP-30  
May 20, 1981

VENDOR SERVICE PUBLICATION

Subject: Bendix Service Bulletins 599A, 609A, 610,  
613, 614

**SERVICE BULLETIN NO. 599A**  
(Supersedes Service Bulletin No. 599)  
Engineering Aspects are  
FAA Approved

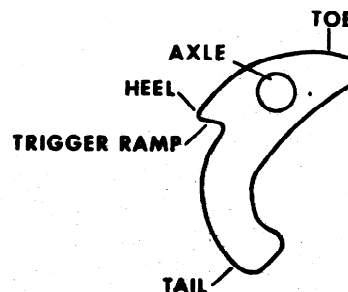
Figure 1. Terminology

- a. Bend the end of a stiff wire into a right angle 1/8 inch long, maximum.
- b. Position impulse coupling so that heel of flyweight (see figure 1) is adjacent to stop pin. Reach

between cam and flyweight with bent wire, as near as possible to the stop pin, and pull outward on the flyweight as shown in figure 2.

d. If less than 0.017 inch clearance exists, this is cause for immediate rejection of the impulse coupling cam assembly, or possibly the entire impulse coupling. Refer to the applicable Magneto Overhaul Instructions for inspection procedures to determine if other impulse coupling parts are still serviceable.

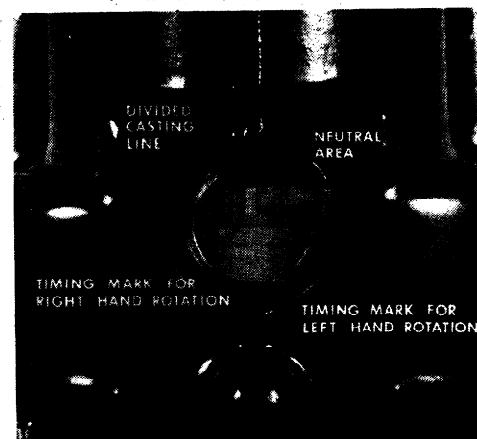
Figure 1. Alignment of Magnet Marks —  
Right Hand Rotation

- a. Turn engine in direction of normal rotation toward the firing position of No. 1 cylinder on the compression stroke. As this point is approached the timing ribs or marks on the rotating magnet should begin to appear in the open viewing hole.
- b. Continue turning the engine slowly, still in the direction of normal rotation, until the proper timing mark on the rotating magnet is centered in the viewing hole. Figure 1 illustrates the timing mark centered for a right hand rotation magneto. A left hand rotation magneto would have the left hand mark centered. Eight cylinder magnetos will show an "R" line or an "L" line on the rotating magnet through the viewing hole.

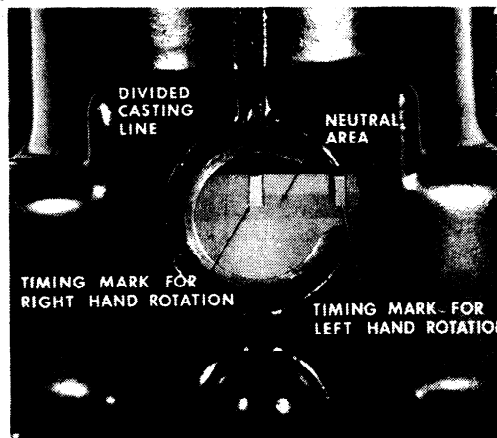
Figure 2. Alignment of Magnet Marks —  
Right Hand Rotation

- b. Continue turning the engine slowly, still in the direction of normal rotation, until the proper timing mark on the rotating magnet is centered in the viewing hole. Figure 2 illustrates the timing mark centered for a right hand rotation magneto. A left hand rotation magneto would have the left hand mark centered. (See figure 2.) Eight cylinder magnetos will show an "R" line or an "L" line on the rotating magnet.

one cylinder firing position until proper timing mark on rotating magnet is in the center of the viewing hole. (See figure 2.)
